Review: 'An under-appreciated masterpiece: conservation of the great Jesse Tree window in Wells cathedral' lecture by Steve Clare ACR FMGP

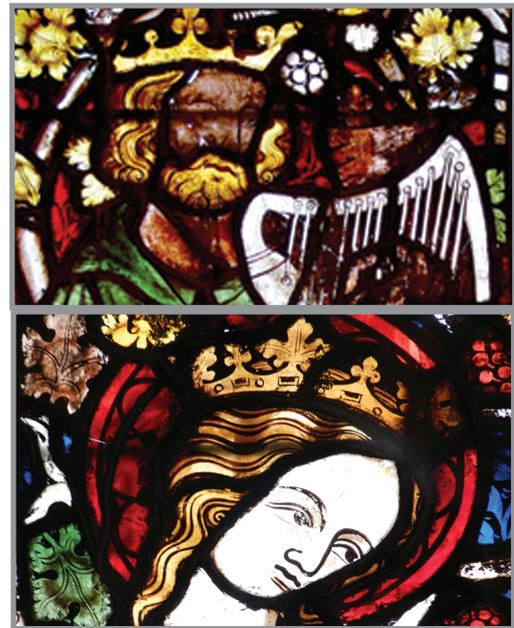
The team used back-painting on the leaves of the glass, which harmonized with the stonework and avoided the need to stress glass by removing it from its framework. Glass that was only lightly corroded was left. If affected by manganese browning (below) it was lightly cleaned (no chemicals, just ionized water). This alone greatly enhanced the brilliance of the colour.
