STAINED GLASS CONSERVATION REPORT

After winning a competitive tender, Holy Well Glass was asked to carry out conservation works at Arundel Cathedral. Main works comprised of re-leading and/or partial re-leading and repair of the Great Rose Window on the West Front. Ancillary works included repairs and re-leading to the plain glazing of the Gable Apex Window, and two narrow windows on the newel staircase turret, both on the West Front. Basic cleaning to surrounding masonry was carried out, and for the gable apex window, further brush cleaning was necessary to remove the 'beard' of moss and lichen below it. The relevant windows are marked on adjacent diagram.

The Great Rose Window on the west façade sits above the organ gallery. The stained glass was made for the Victorian French Gothic cathedral in 1873 by the esteemed C19th stained glass workshop Hardman's of Birmingham. The window contains 15 outer cinquefoils, 15 inner trefoils, 15 smaller trefoil headed lights, and 1 central circular light. There are also numerous 'eyes' between the tracery elements. In the centre is the Blessed Virgin with the Holy Child around her, and angels bearing incense in the inner trefoils. In the out

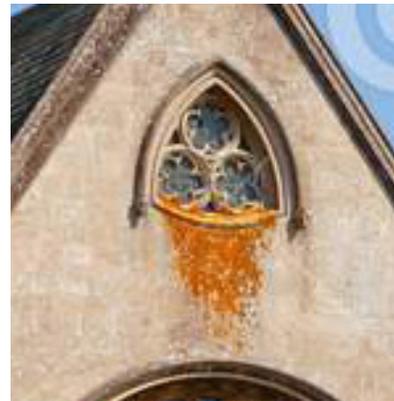
A heavy concentration of moss & lichen below the Gable Apex Window

During site removal of glass panels, before conservation, basic cleaning to masonry was carried out on the Great Rose and Turret windows, and heavy moss and lichen growth to ashlar walling below Gable Apex Window, cleaned off stonework with brushes. Left site clean.

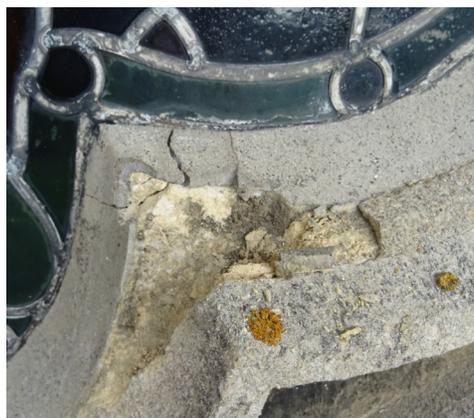
On-site removal, hard Portland cement mortar

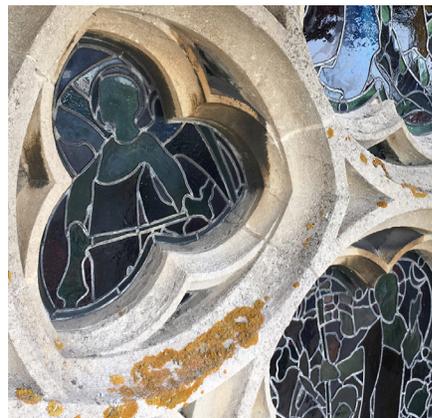
On-site removal, moss & lichen growth visible on the window masonry

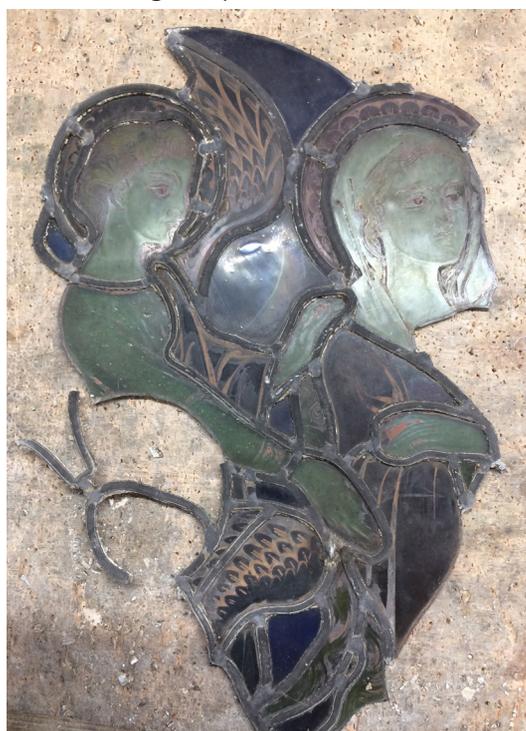
Panel E14 during dismantling

It was necessary to dismantle fully or partially, some panels that were not structurally sound, and some areas to facilitate repairs to the glass. Presumed in favour of renewing leadwork where weakness was evident, as future opportunities will be limited due to the extreme inaccessibility of the window.

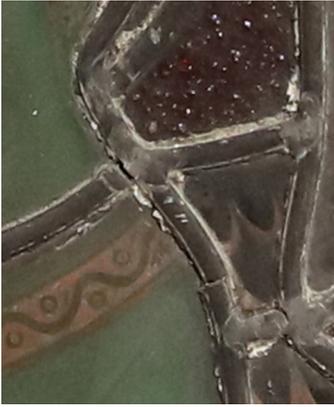
Broken leads and solder joints

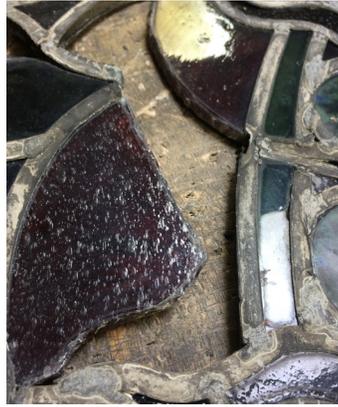
Weak panel coming apart naturally

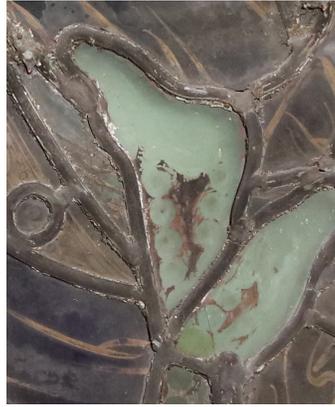
Leaching cement internally

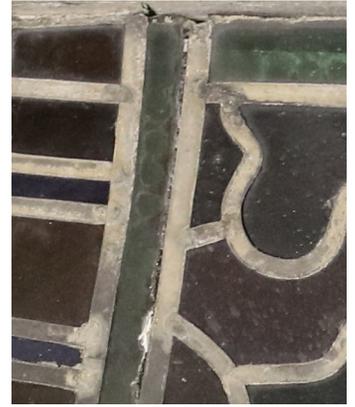
Lead coming away from the glass, external view

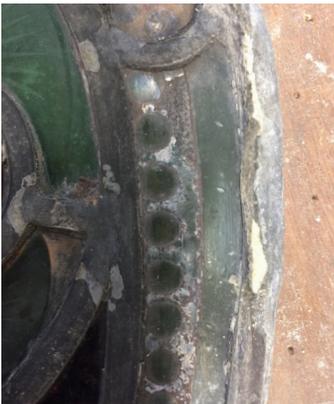
Painted border glass & perimeter lead

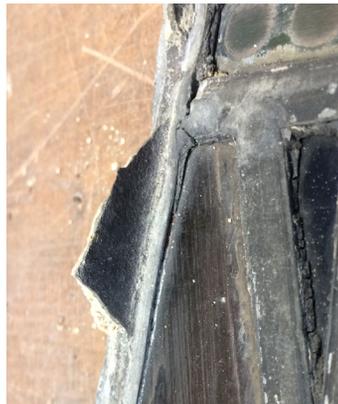
Remains of hard Portland cement mortar on perimeter lead

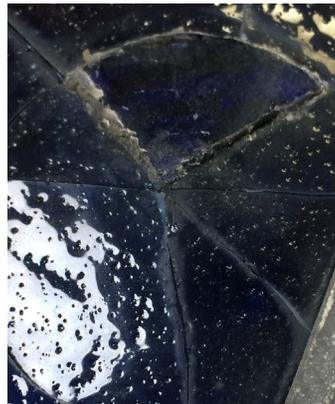
Multiple cracked piece, external

Impact breaks, single/double breaks and small gaps repaired using Araldite 20:20; a conservation grade two-part epoxy resin. Silicone used where a more flexible mend was required, and where glass was too thin to work with resin.

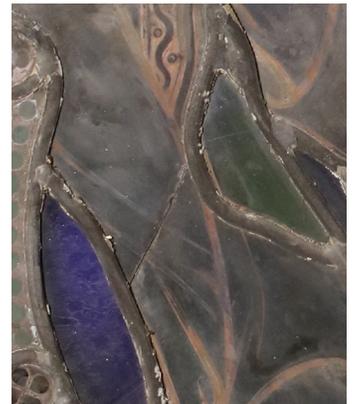
Single crack, internal

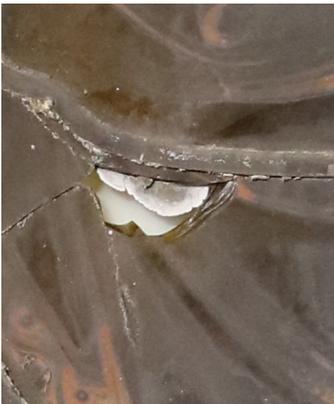
Hole in glass & historic putty repair, internal

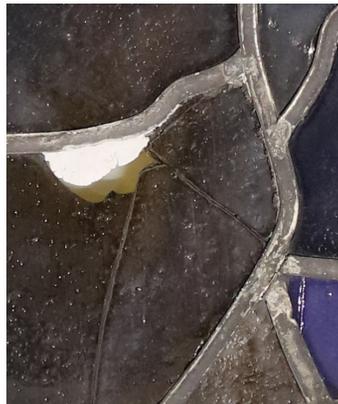
Hole in glass & historic putty repair, external

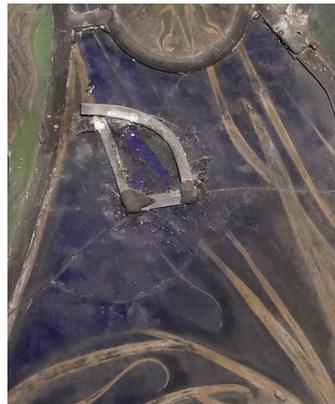
Historic strap lead repair, internal

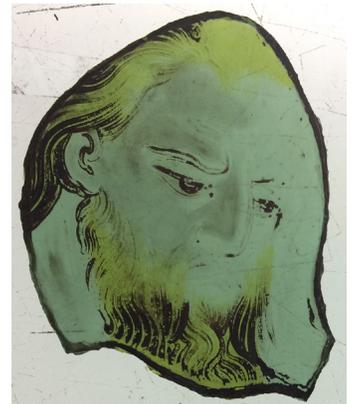
Moderate paint loss, internal

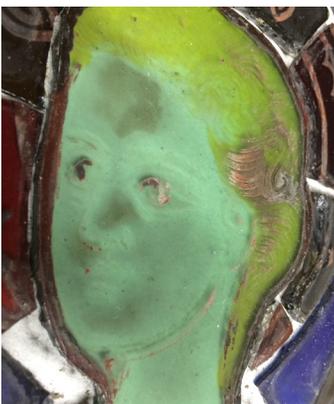
Severe paint loss, internal

Plates were produced to reinforce lost painted detail from iconographically important areas of The Great Rose Window. The larger central 'A' panel and the large cinquefoil 'E' panels in the outer rose were selected for this treatment. They were felt to benefit most significantly; it was in these larger panels the white glass was particularly glaring where the paint had been lost, drawing the eye from the design intent of the window. Plates were clear 1.2mm thick optical glass, painted with kiln-fired glass paint, and heat formed to the contours of the original pieces. Paint and stain tests were conducted to achieve a correct match. The detail was hand-painted to match the original design intention, using evidence within the existing pieces. For areas of total paint loss, a full repaint was applied to the plates following the 'ghost' image on the original glass, whereas those pieces with less paint loss were only partially repainted. Once kiln-fired the paint enhanced plates were fitted with copper foil around the perimeter, in readiness for fitting to the conserved panels during site-refit.

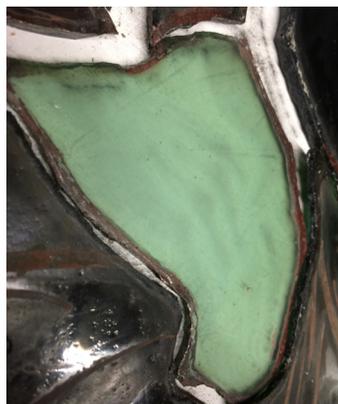
Total paint loss, internal

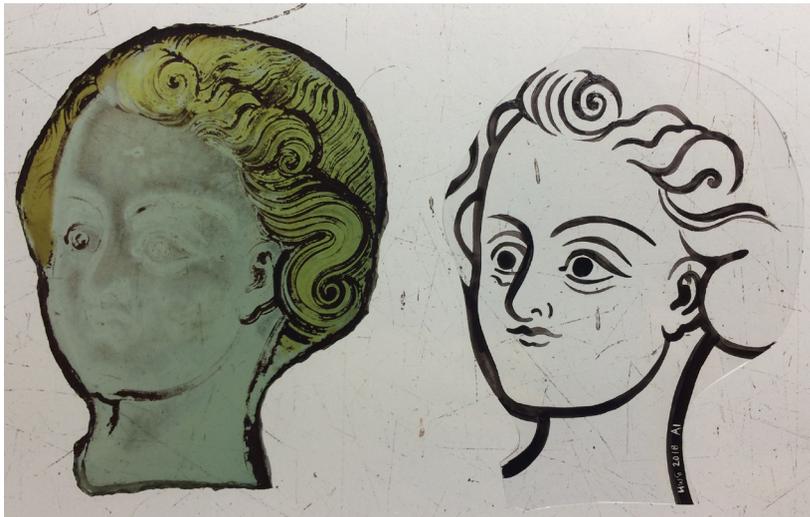
Original piece, left, with paint loss, & new paint enhanced plate, right

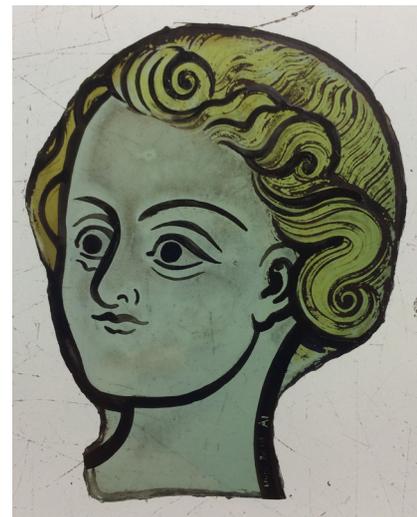
Original piece, with paint loss, below, & new paint enhanced plate, atop

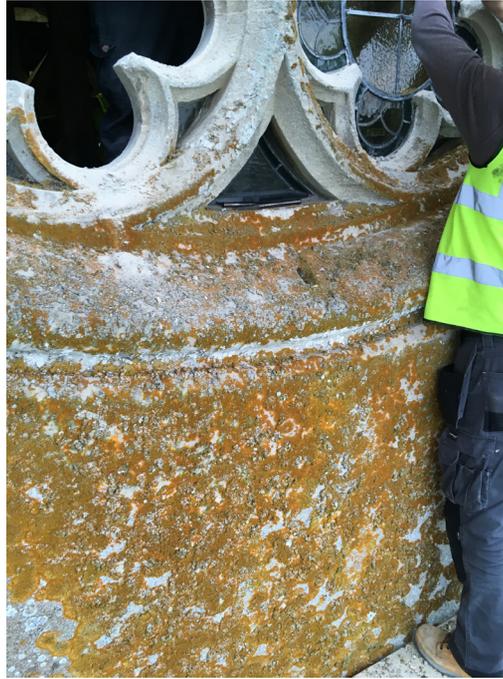
Gable Apex Window before stone cleaning

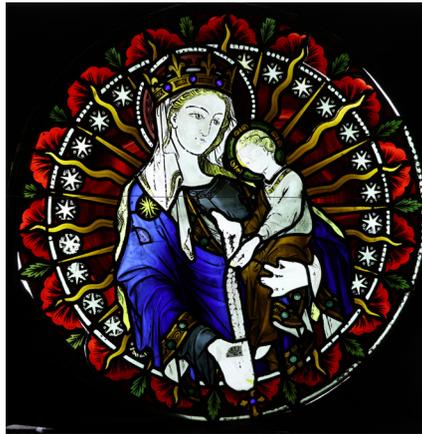
Panel A1, before conservation, transmitted light

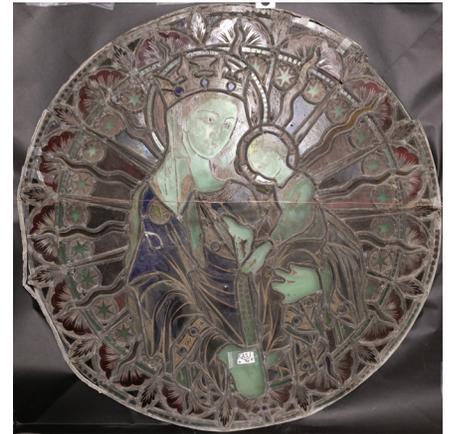
Panel A1, before conservation, reflected light
