## STAINED GLASS CONSERVATION REPORT

Following a condition survey Holy Well Glass was asked to carry out conservation repair works at St. Michael's Without, Bath. This focused on localised vandal damage to the base panel (1a) of the central lancet of the East Window, 820mm x 843mm approximately. How the damage occurred is uncertain, as the entire area outside was covered by heavy duty bird netting. There were no objects heavy enough to have caused the damage within the netting. It is most likely someone got inside the netting via the adjacent rooftops with the intention of breaking in, but were put off by the extent of the drop revealed when pieces of glass were smashed out. The broken panel can be seen in the accompanying images. Sympathetic repair works included the removal of the panel to the workshop, partial dismantling to allow access to the broken sections, complex edge-bonding of the many fragments of glass, re-leading, waterproofing, and finally refitting in-situ.

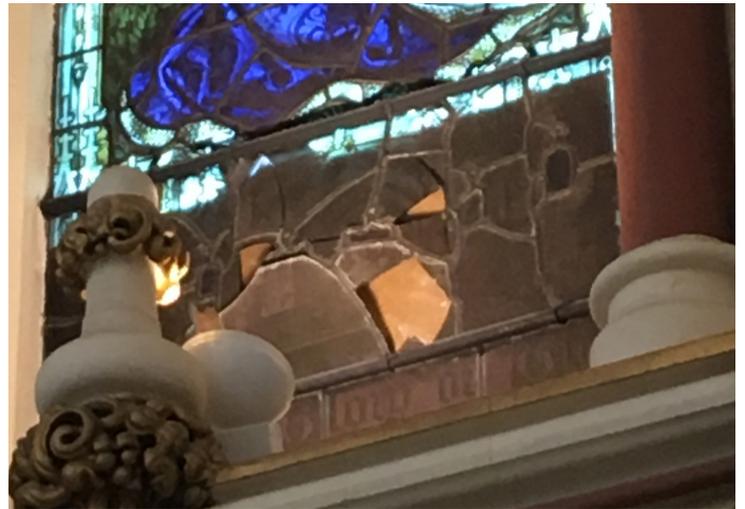
East Window, panel 1a, internal view, before removal for repair

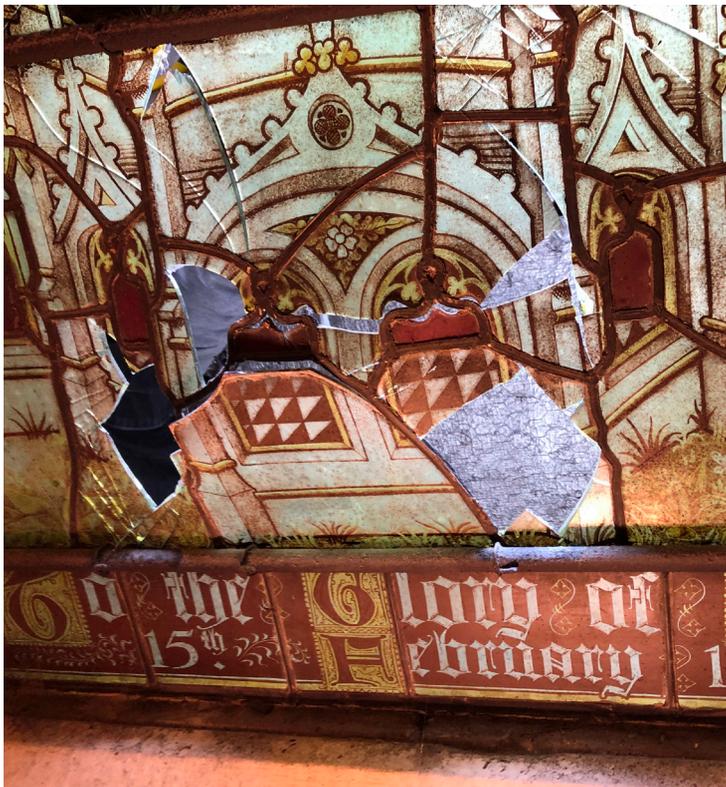
East Window, panel 1a, internal view, before removal for repair

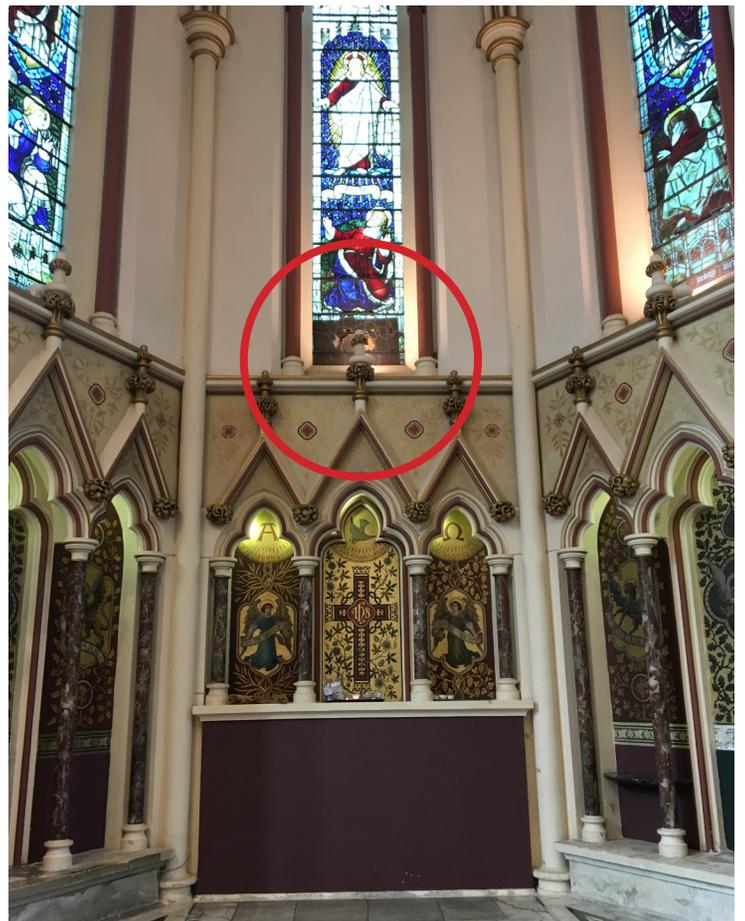
East Window, panel 1a, internal view, before removal for repair

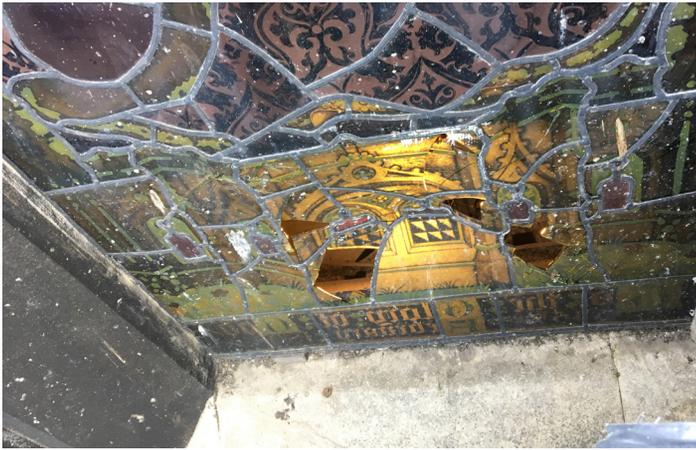
Substantial bird droppings across two thirds of the external panel surface

Internally there was generally a low level of surface dust. This was more extensive behind the two support bars at the top and centre of the panel, where splashes of black bar paint were also evident. Externally splashes of bird droppings covered the bottom two thirds of the panel.

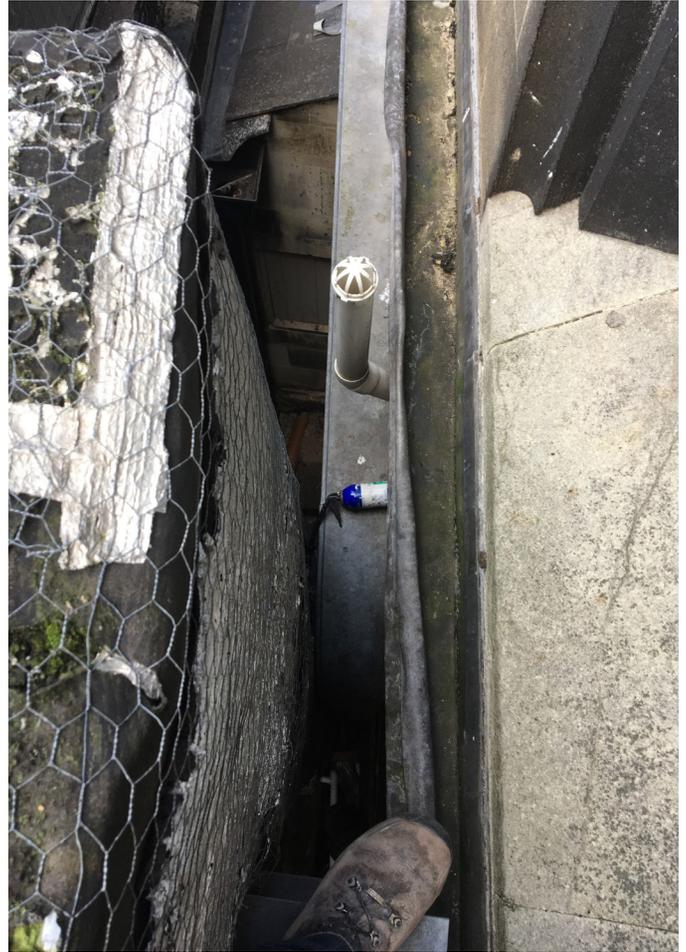
External view - limited access between the window and the ventilation unit

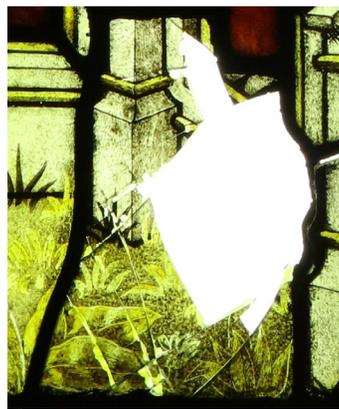
Complex breaks and holes in the glass

All broken glass was re-assembled and edge-bonded. Impact breaks, single/double breaks and gaps repaired and filled using Araldite 20:20; a conservation grade two-part epoxy resin. One cracked section and simple glass break was repaired employing the copper foil method; the break edges of the glass were coated with a thin adhesive strip of foil, the pieces were brought together, and the foiled sections soldered to made one re-united piece.

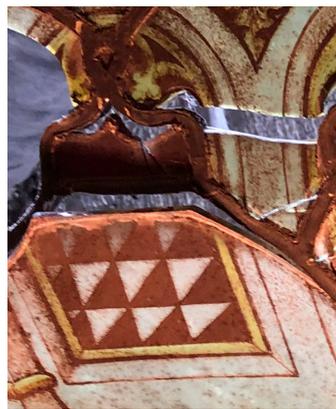
Distorted lead came, where glass and lead have become separated

Panels have been leaded with commercially available lead comes, in a profile matching the original lead width and depth; 3/16" and 1/4" for internal leads, 1/4" for the top perimeter lead, and 1/2" for all other perimeter leads. The soldering technique has been mirrored also, soldered with 60/40 lead/tin solder.

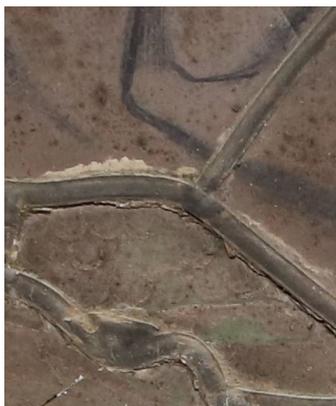
Cement brittle and leaching out of the leads

The painted front face, of the panel was hand puttied with linseed oil putty stained with lamp black pigment. The back face was cemented with traditional leaded light cement, to the following recipe:  
- 4 white spirit, 1 boiled linseed oil, 1 raw linseed oil, 5% gold size, calcium carbonate and lamp black pigment.

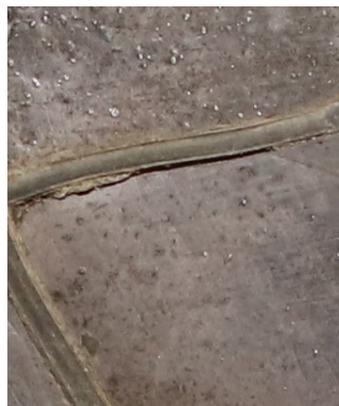
Cement missing/lost from underneath lead came

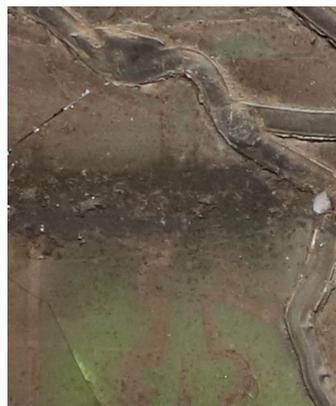
Dirt/soot etc. collected behind the support bars

The painted surface of the glass was monitored with a binocular microscope. Each piece of glass was cleaned using a 50/50 mixture of ethanol and de-ionised water on cotton buds and soft brushes. Leaded light cement was removed with a scalpel. Areas not dismantled were also cleaned, as above, but within the lead matrix.

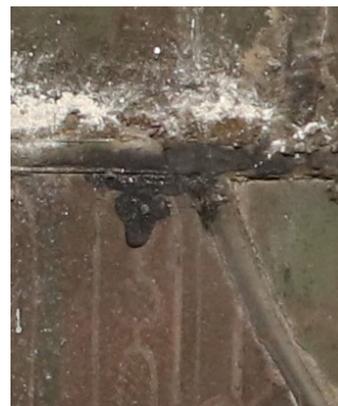
Stray black bar paint evident on the glass and lead

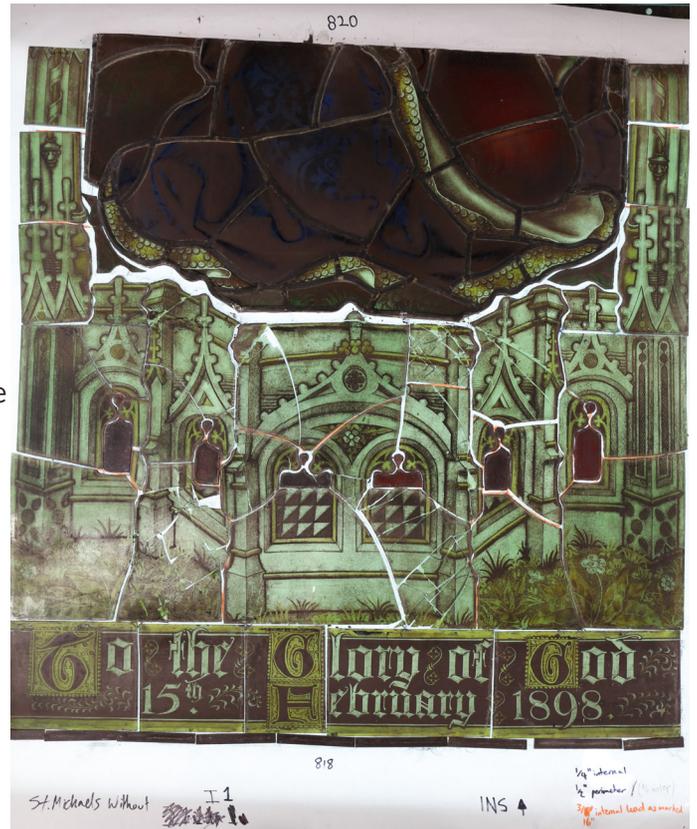
Part dismantled panel, top drapery section remained intact

It was necessary to dismantle some sections where the panel had suffered most damage, and to facilitate repairs to the glass. Presumed in favour of retention of leads whenever possible. Therefore, the top section of the panel remained intact.

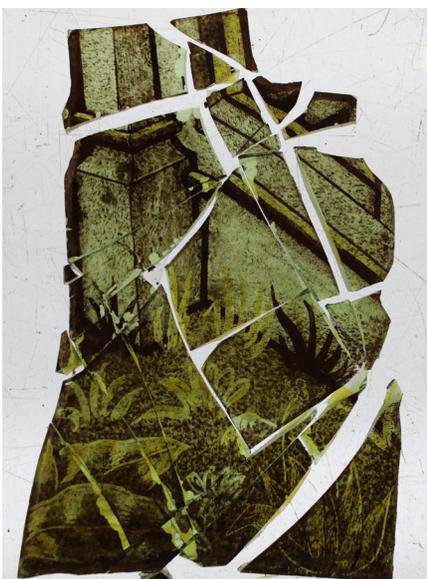
A severely cracked piece to be edge-bonded

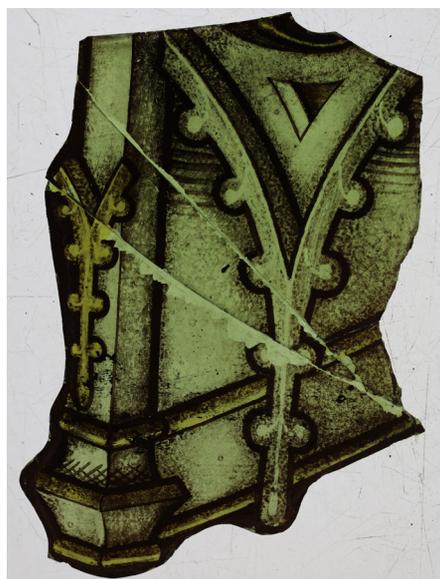
A cracked piece clearly showing glass severely shored off at the broken edges, assembled for edge bonding

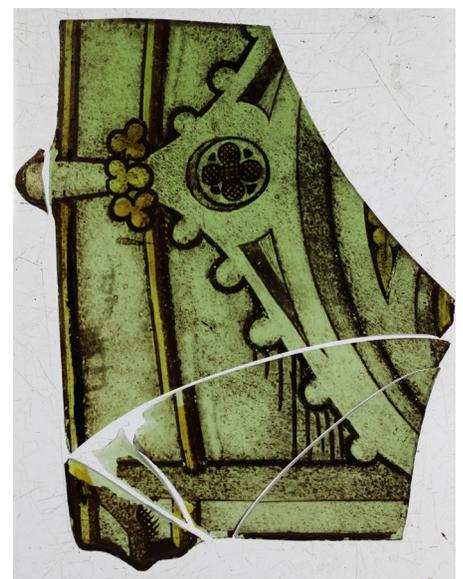
Cracks as well as gaps in the glass, assembled for edge bonding

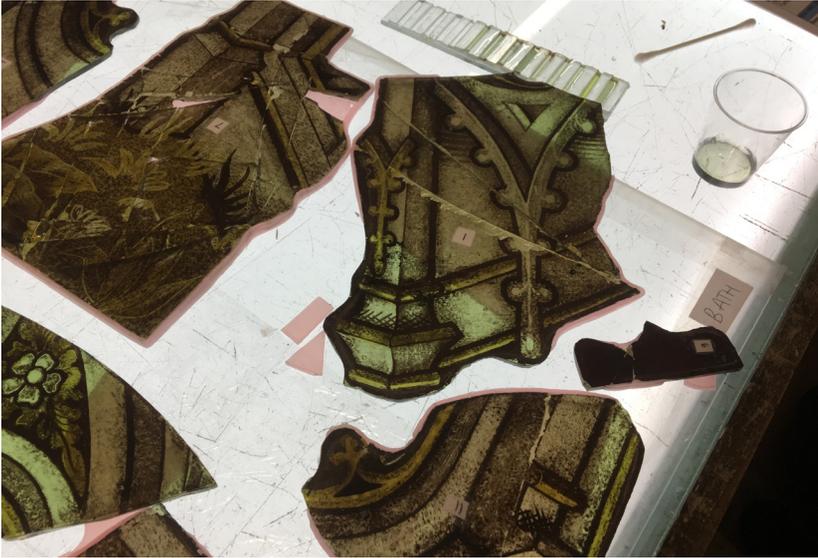
Preparation for green tinted resin infills

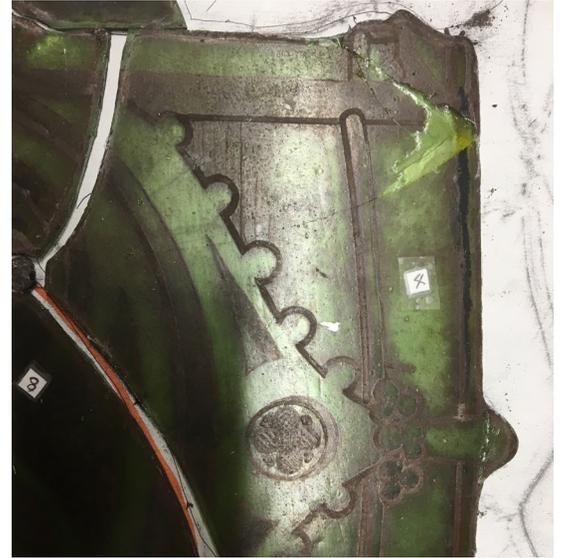
Broken piece after edgebonding, and before cold painting the resin fill

For edge-bonded areas, glass with stable paint was then cold coloured for legibility.

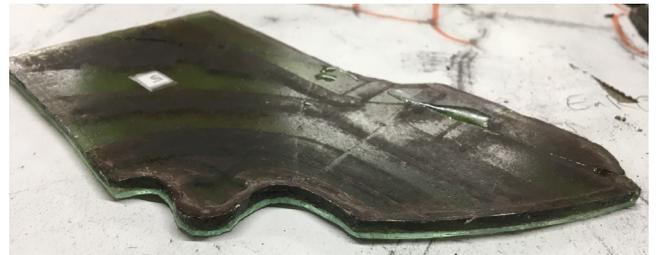
Clear kiln-formed backing plate attached to edge-bonded piece, internal face

To protect the newly edge-bonded pieces against the elements clear backing plates were made for each individual piece. 1.4mm optical glass was used, heat moulded to match the curves/texture of the original glass. All plated pieces were sealed about the perimeters with silicone.

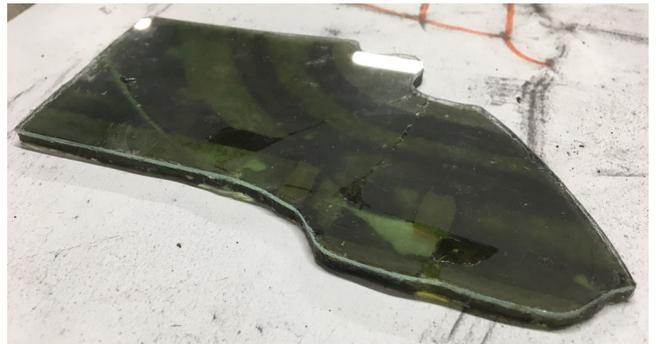
Clear kiln-formed backing plate attached to edge-bonded glass, external face

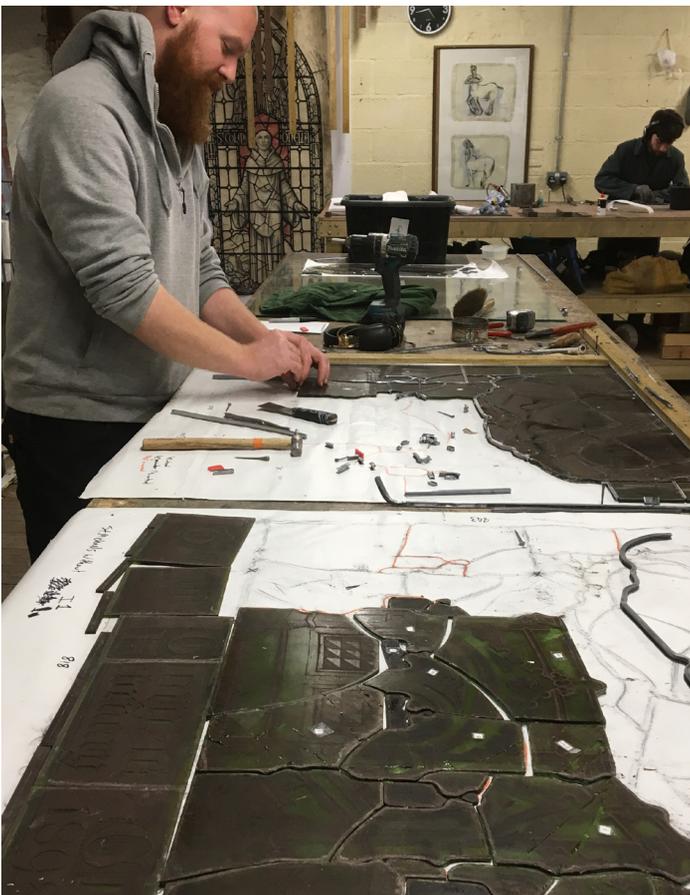
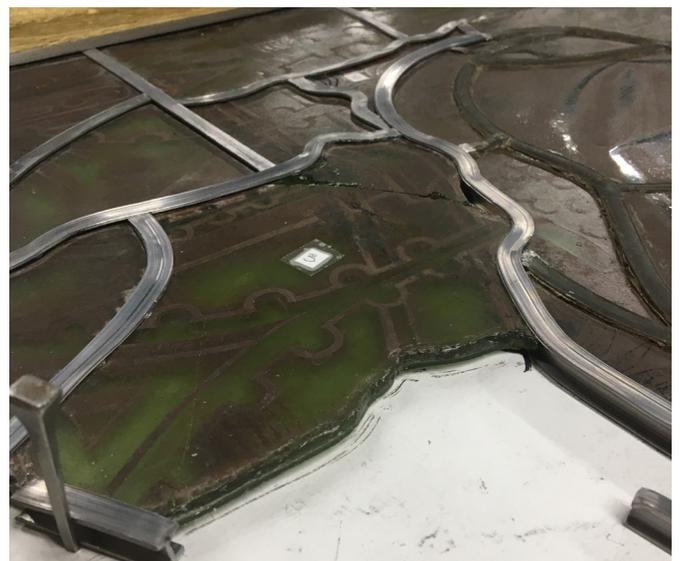
Above and left: - re-leading, incorporating the repaired glass and the non-dismantled panel section

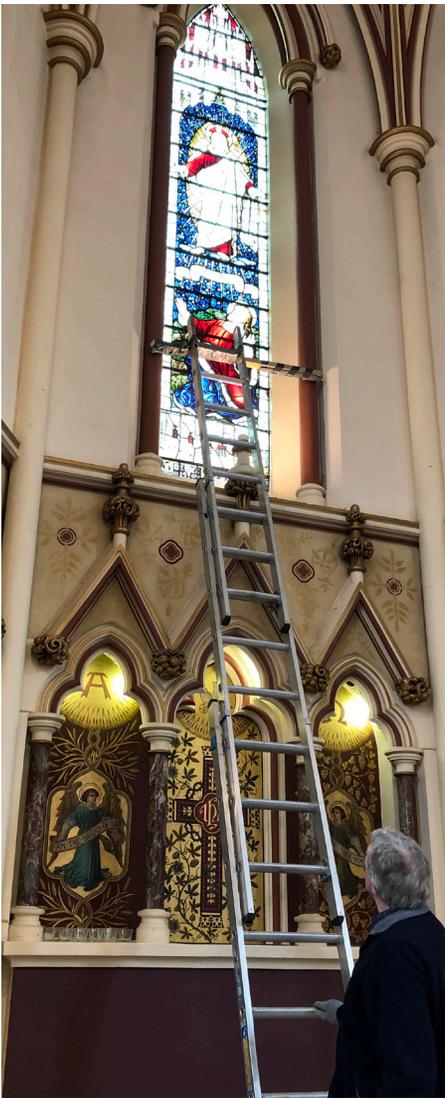
On site refit to East Window panel 1a, internal view

The panel was returned to the building in the week of 8th May 2019. Internal access was gained via ladder. As during removal, external access was very limited, and a safety harness was used once again, using the temporary fall arrest point. Upon return to site the temporary twin wall polycarbonate sheet was removed. In-situ saddle bars were de-scaled, and the panel fitted into the stonework. The panel was installed in the original 'stacking' or 'saddle' formation, and sealed into the building with traditional lime-mortar (3 Aggregate: 1 St Astier lime NHL3.5). Copper ties were tied, and the panel division puttied with linseed oil putty stained with lamp black, to make water tight. Left site clean.

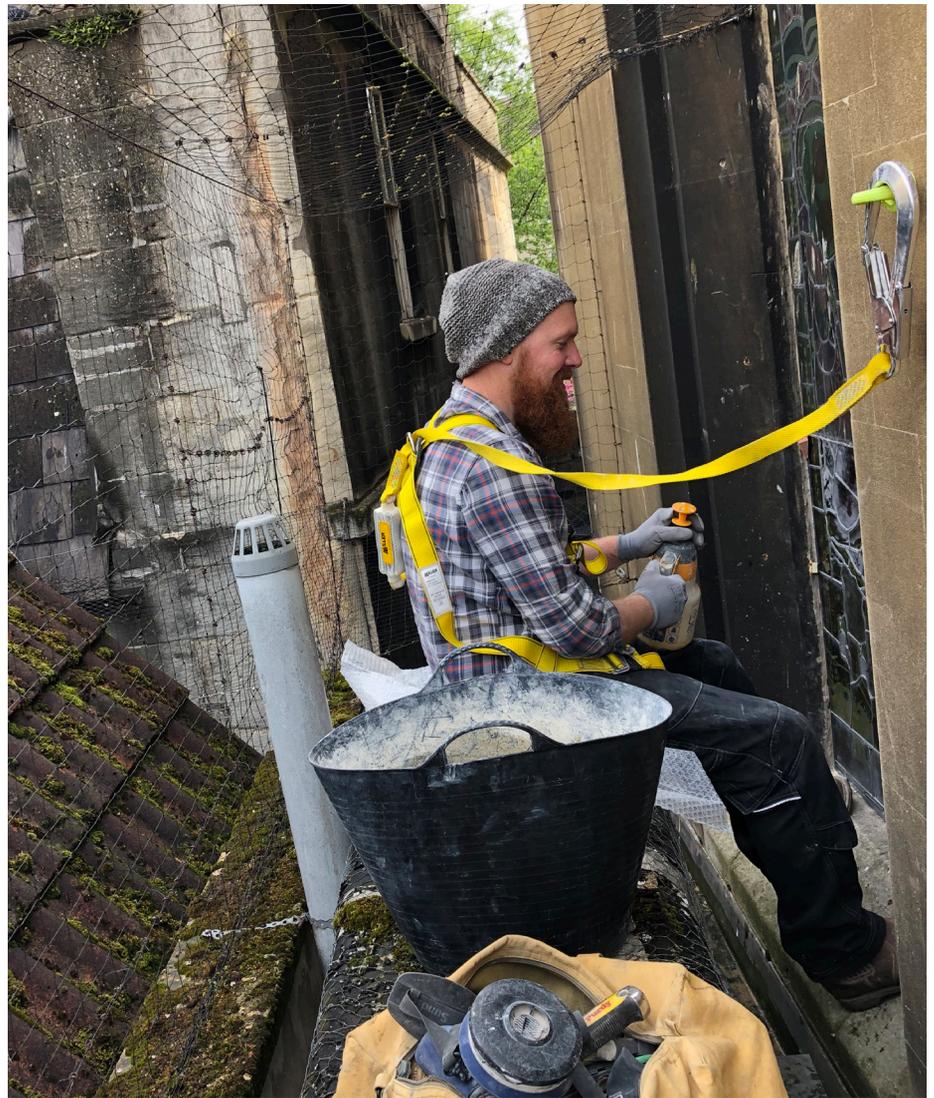
On site refit to East Window panel 1a, external view

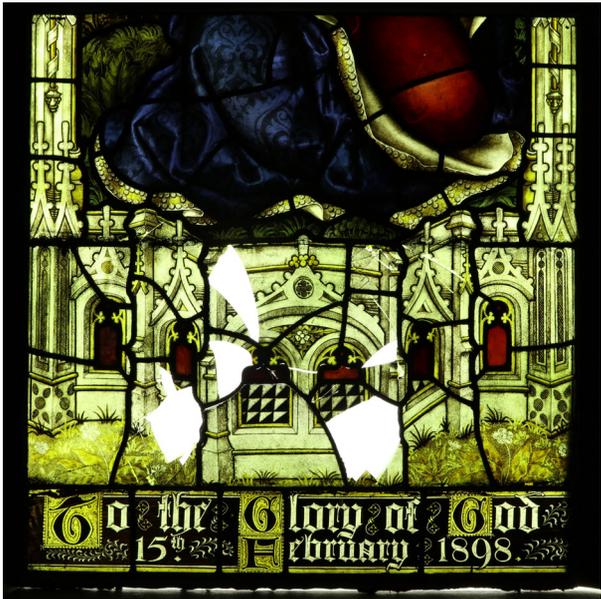
Panel 1a, **before conservation**, internal view, transmitted light

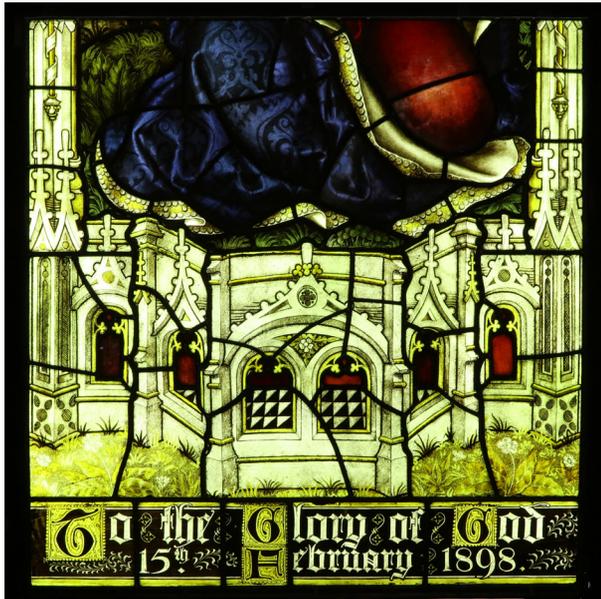
Panel 1a, **after conservation**, internal view, transmitted light

The panel is stable, clean, fixed sound, and weatherproof. The integrity of the panel has been maintained by collecting, keeping, and repairing all the original broken fragments, and re-inserting them into the panel.

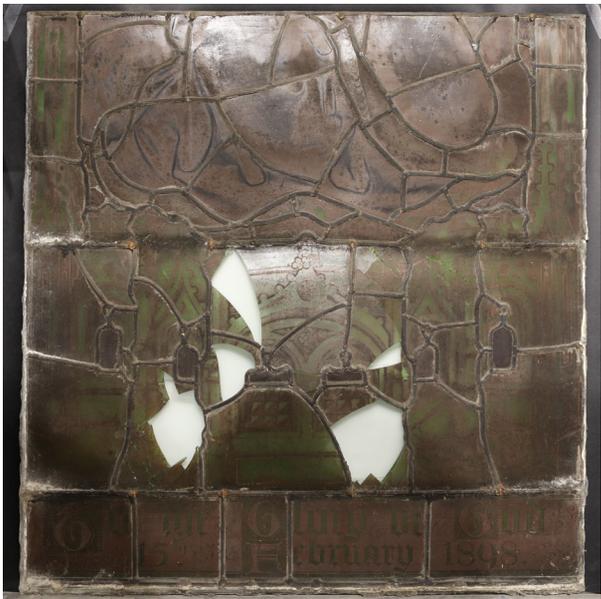
Panel 1a, **before conservation**, internal view, reflected light

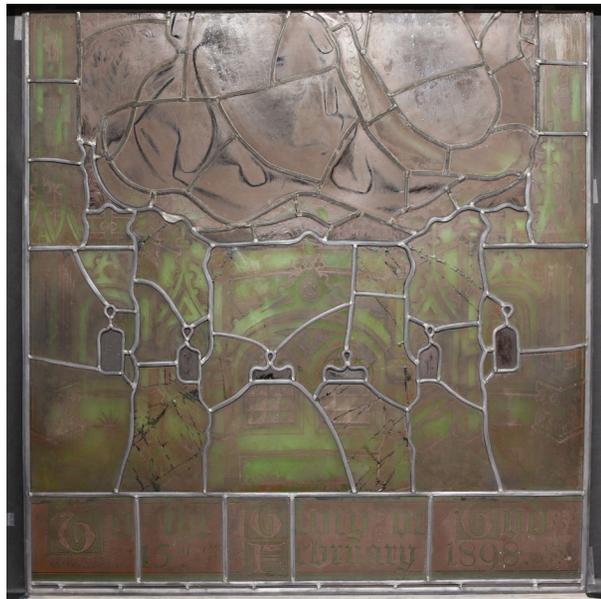
Panel 1a, **after conservation**, internal view, reflected light

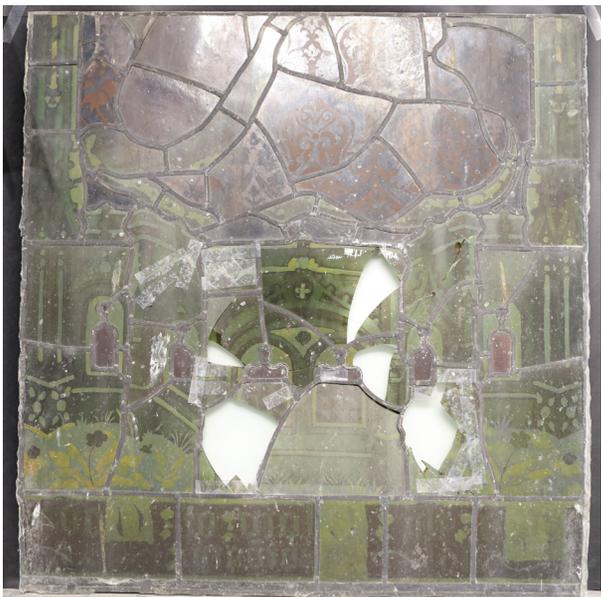
Panel 1a, **before conservation**, external view, reflected light

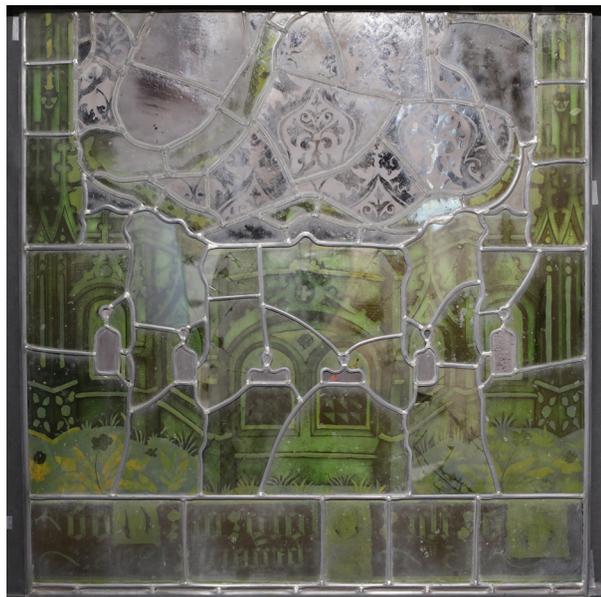
Panel 1a, **after conservation**, external view, reflected light
