REPLACING TIES IN SITU: METHOD 2

This article follows on (although belatedly) from the article about 'Replacing wire ties in situ' in issue 38 of June 2007, where Keith Hill addressed the difficulties experienced by glaziers/conservators when faced with the task of in-situ vertical soldering and replacing failed copper ties with new ones. Here we report another method of soldering wire ties in situ.

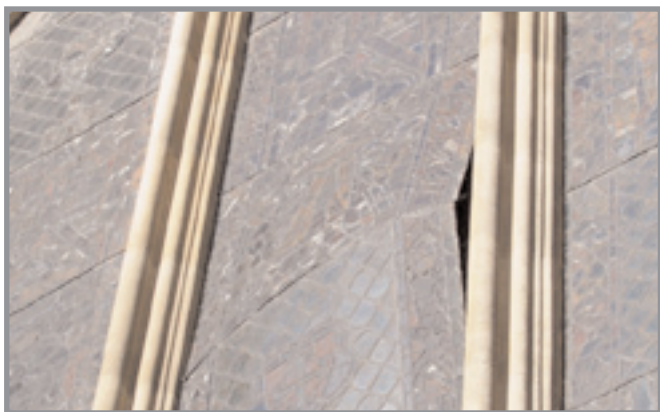
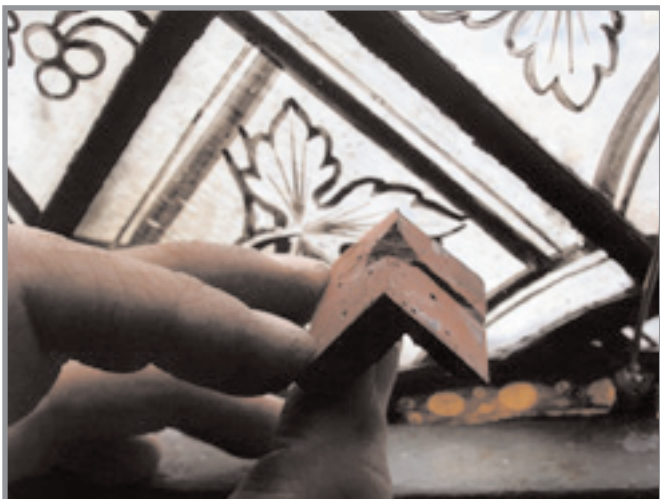
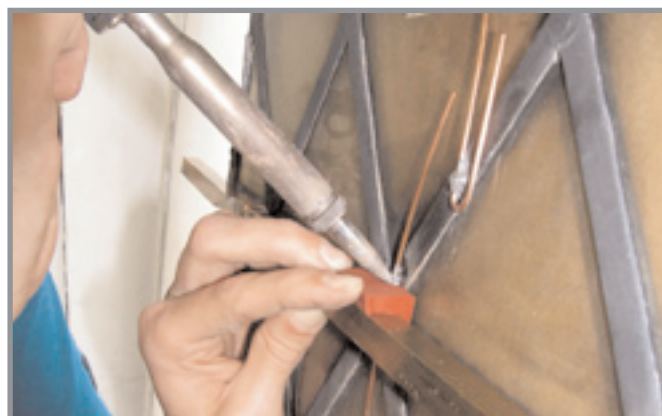
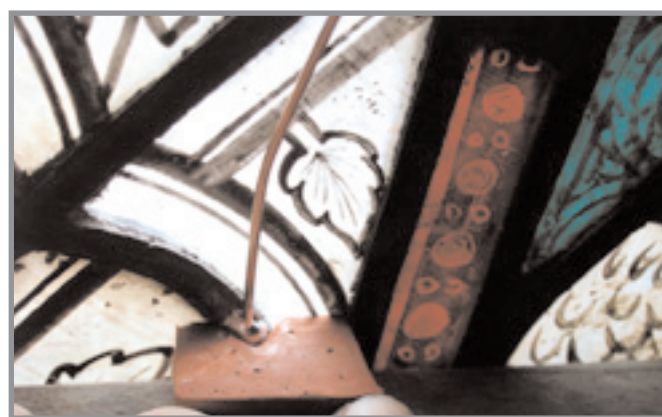
(top) Panels after the storm; (above) cut rubber mould; (top right) workshop trials; (above right) attached tie in place.

Our solution to the problem was prompted by a discussion with a colleague who had cast his own lead figures using a flexible heat-proof silicone rubber. We thought that this material would serve well as a mould for solder as it designed for low-melt metals up to 316 degrees centigrade. After much trial and error, we cut a mould from cold-set silicone rubber shaped so that it could be slotted in behind the square bar. This mould held a newly prepared copper tie snugly in place (with tallow flux applied) against the panel (photos below left and below).

The new tie sat about 3 mm higher than the bar. We successfully cleaned suitable lead solder joints to bright metal with a scalpel blade in preparation for the new tie, tinning the lead in preparation. We used a thinner gauge wire where the only option was to solder onto a length of lead.

Though we found we could use a small micro-flame with caution, we favoured a 110 V – 100 W iron for the safety of the glass and the building. The mould allowed us to heat the solder for as long as it was needed for good solder-to-metal contact whilst holding the wire in place with pliers. The resulting solder blobs were reliably uniform and neat (photo below). We twisted the ties and folded them back on top of the bar so they were away from the risk of snagging and out of sight.

We soldered more additional ties than might normally be the case when, working on the bench, to help provide better long-term support. One mould stood up to being used about 40 times before it started to disintegrate. The rubber could also be held in place with the fingers if needed, as it is a good insulator against heat.
