REPLACING TIES IN SITU: METHOD 2

This article follows on (although belatedly) from the article about 'Replacing wire ties in situ' in issue 38 of June 2007, where Keith Hill addressed the difficulties experienced by glaziers/conservators when faced with the task of in-situ vertical soldering and replacing failed copper ties with new ones. Here we report another method of soldering wire ties in situ.

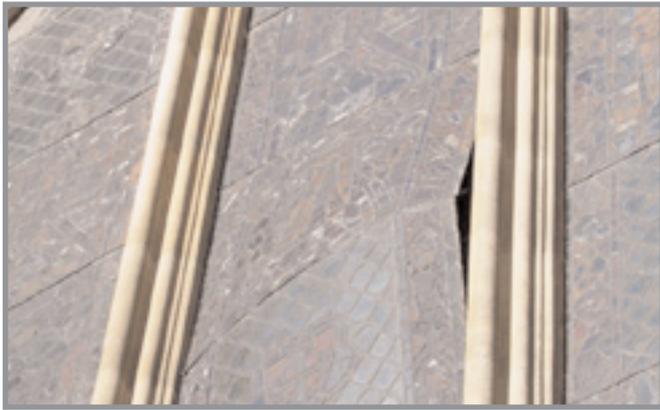
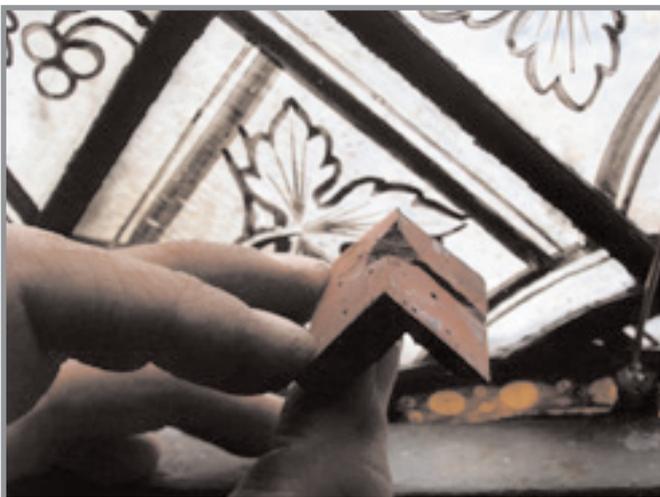
The problem arose in March 2007 when we were called to a church to rescue two panels that were in danger of falling out. The church had been hit by storms on the previous afternoon. The opening of a door on the north side of the building had caused enough air pressure to build inside, forcing the panels of glass (19th C. copy of a 14th C. window) outward from their supporting structure (photo above). In this case the existing ties were made of lead; many were weakened with age and had fractured. Fortunately, the panels were wedged (in their new alarming position) by the mullions and held by the remaining ties at the divisions. We were able to access and remove the displaced panels promptly by cherry-picker. (There was remarkably little damage to the lead and none to the glass.) Internal scaffold was erected to enable the re-fixing of this panel; this also allowed us to survey all the ties of this three-light window and its associated tracery panels. From this we counted that around 50 ties had fractured or were loose across the window. As the fractured ties were found sitting alongside stable intact ties, we decided that it would be preferable to leave the glazing bar undisturbed when fixing new ones.

(top) Panels after the storm; (above) cut rubber mould; (top right) workshop trials; (above right) attached tie in place.

Our solution to the problem was prompted by a discussion with a colleague who had cast his own lead figures using a flexible heat-proof silicone rubber. We thought that this material would serve well as a mould for solder as it designed for low-melt metals up to 316 degrees centigrade. After much trial and error, we cut a mould from cold-set silicone rubber shaped so that it could be slotted in behind the square bar. This mould held a newly prepared copper tie snugly in place (with tallow flux applied) against the panel (photos below left and below).

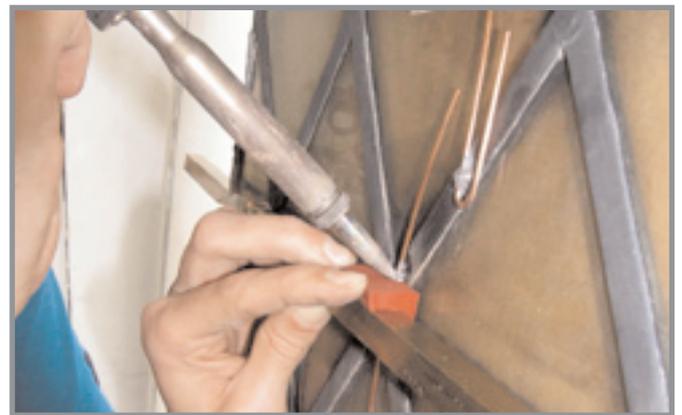
The new tie sat about 3 mm higher than the bar. We successfully cleaned suitable lead solder joints to bright metal with a scalpel blade in preparation for the new tie, tinning the lead in preparation. We used a thinner gauge wire where the only option was to solder onto a length of lead.

Though we found we could use a small micro-flame with caution, we favoured a 110 V – 100 W iron for the safety of the glass and the building. The mould allowed us to heat the solder for as long as it was needed for good solder-to-metal contact whilst holding the wire in place with pliers. The resulting solder blobs were reliably uniform and neat (photo below). We twisted the ties and folded them back on top of the bar so they were away from the risk of snagging and out of sight.
