HOLY
WELL
GLASS

**Winchester Cathedral,
Conservation of Presbytery
Clerestory Windows NII-NV,
SII-SV, & EI**

October 2015 - October 2017.

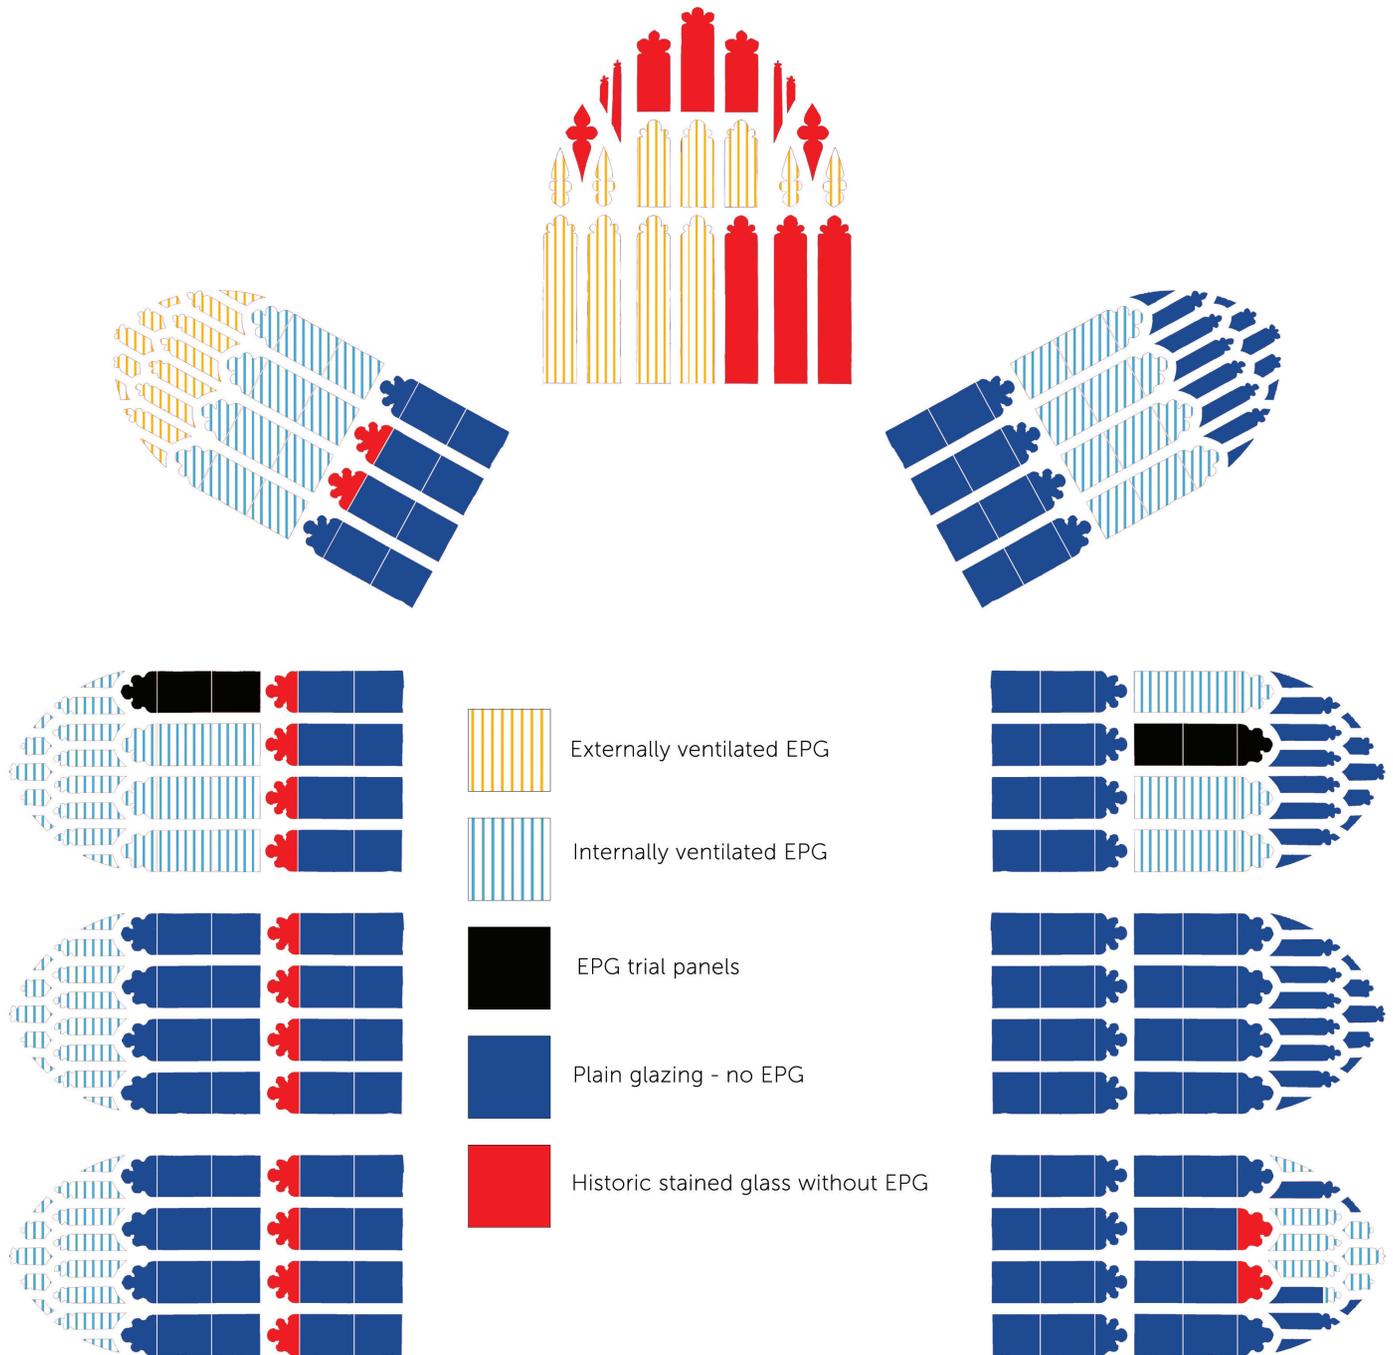
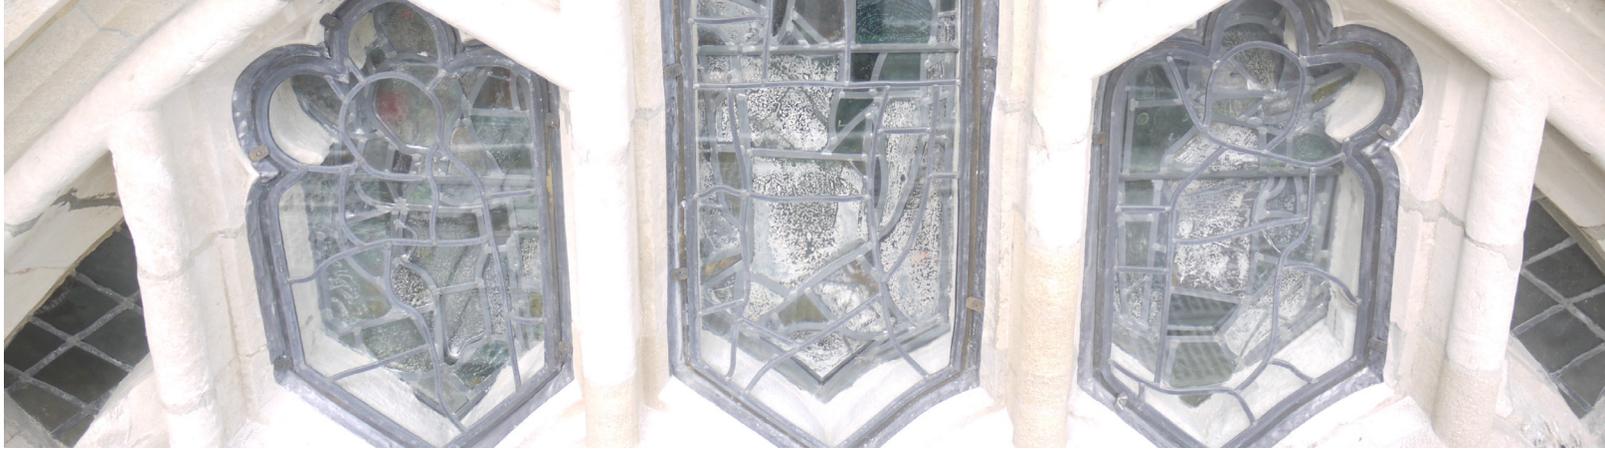
Winchester Cathedral Presbytery Clerestory Environmental Protective Glazing

All windows have been vented internally, with the exception of the tracery section in NII, and the East Window, which have been vented externally. Ventilation has been achieved by raising selected panels for base vents, and tilting individual pieces of glass for top vents.. For Windows NII and NIII the external ferramenta is retained by mounting it upon the external glazing system T-bars. Two bespoke designs have been used to frame the glass for the main lights and the more complex tracery sections. They have been designed, manufactured, and installed as follows:

- Cutline drawn for new leaded light glazing using rubbings taken from original stained glass during previous conservation, and site measurements and templates.
- New leaded lights constructed on cutline with approx. 70% of stained glass lead lines, using 1/4 "flat internal leads with a 1/2" perimeter lead, and made with a mix of plain float and Lamberts restoration glass 60:40 ratio.
- For the East Window a simple planar treatment of single sheet horticultural glass was used.
- Lights are divided horizontally to coincide with original stained glass panel divisions.
- New exterior glazing screen cemented in the traditional manner. Leaded light cement made to the following recipe: 2 white spirit, 1 boiled linseed oil, 5% gold size, calcium carbonate and lamp black pigment

- The individual exterior glazing panels are supported on bronze T-bars.
- T bars secured to masonry with bronze wall brackets fixed with non-ferrous screws into plastic plugs. Detailed measurements taken for the main lights including bar positions.
- Each leaded panel has a bronze perimeter frame (10 x12 x 2mm) with pressed corner brackets secured with countersunk stainless steel rivets.
- Glazed panels sealed to frames using black silicone sealant.
- Thin lead skirting soldered to frame edge to create a seal to the stonework when fixed.
- Bronze pins drop through machined holes in the T-bar to secure the panels when fitted.
- Lead sill condensation trays designed, manufactured, and fitted immediately below the main light base panels.

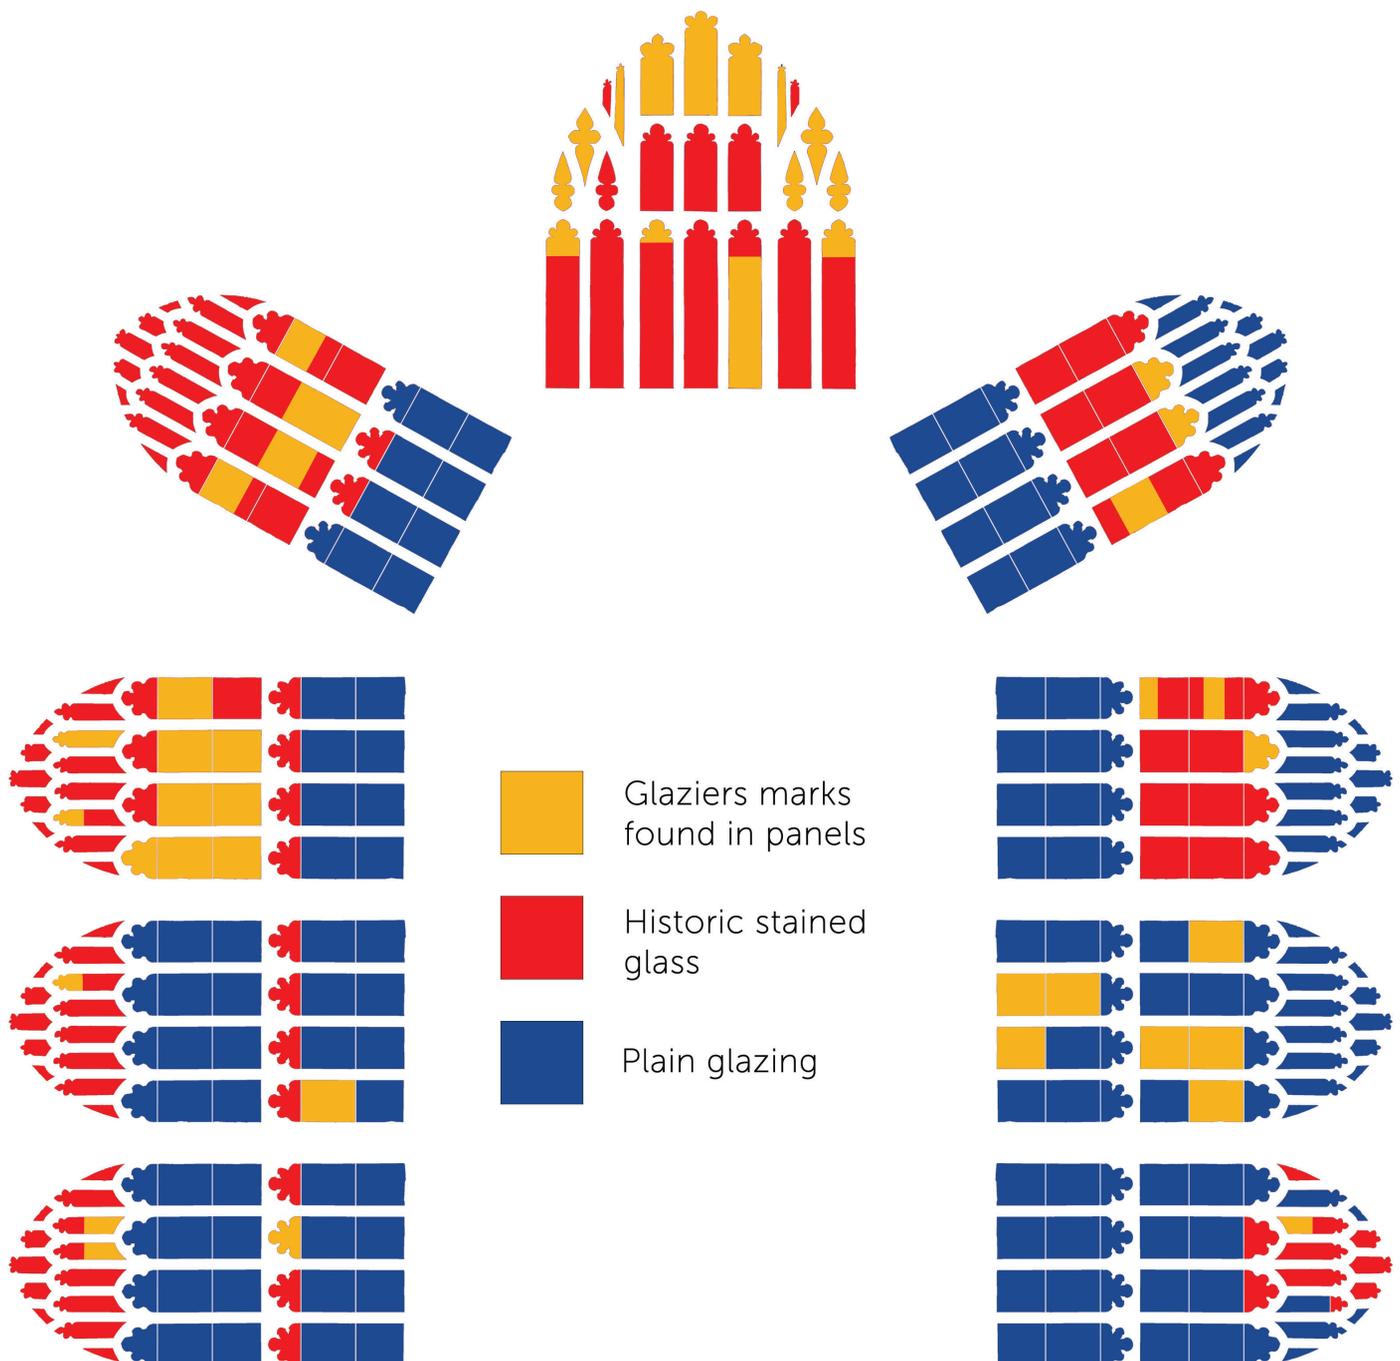
Positions of Glaziers Marks

- A large number of medieval and later glaziers marks were identified and recorded.
- An important survival of 16th century lead, lead ties and lime mortar was recorded and conserved to the traceries of window NII.
- The finger print of a medieval glass painter was recorded to window SII, panel 5d.
- A male head (Window NII, panel A3) was identified as much older than the Thomas Glazier period, probably early 14th C.
