Review: 'An under-appreciated masterpiece: conservation of the great Jesse Tree window in Wells cathedral' lecture by Steve Clare ACR FMGP

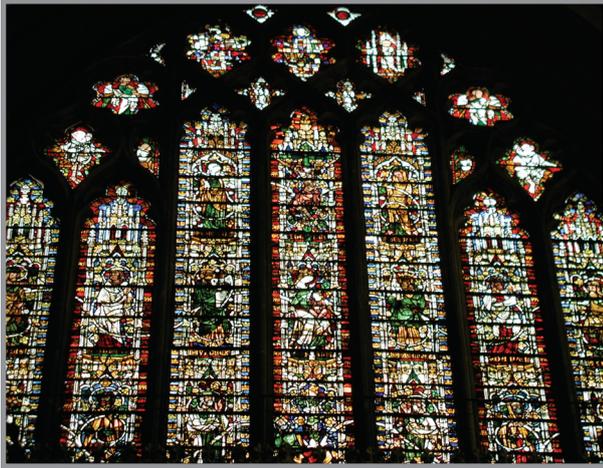
The 1340–45 window, high up at the East end of the choir, is a broad 7-light window depicting the Tree of Jesse (i.e. Jesus's genealogy). It is widely considered one of the finest Jesse Trees in the world partly because of its unusual color palette. Rather than the deep blues and rubies as often seen, its major colours are greens and golds, both pot metal and silver stain (photo above) – hence to locals it is fondly known as 'The Golden Window'.
